Melvin Price Locks and Dam UMR Mile 201
Auxiliary Miter Gate Failure
Bi-Weekly Status Report
6 April 2005

THIS REPORT IS ISSUED BI-WEEKLY

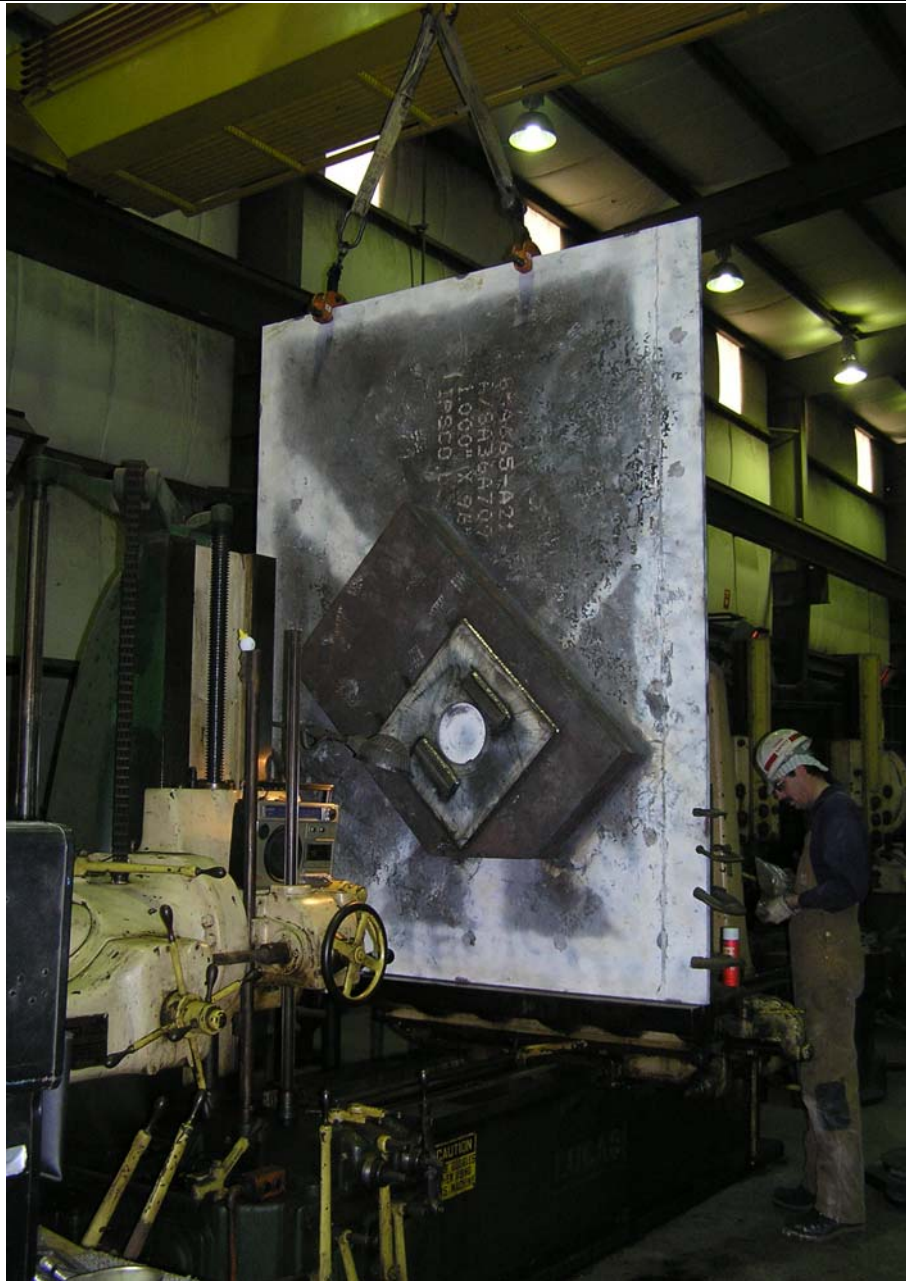
Crew member setting up new diagonal pin box for the boring mill.
6 April 2005

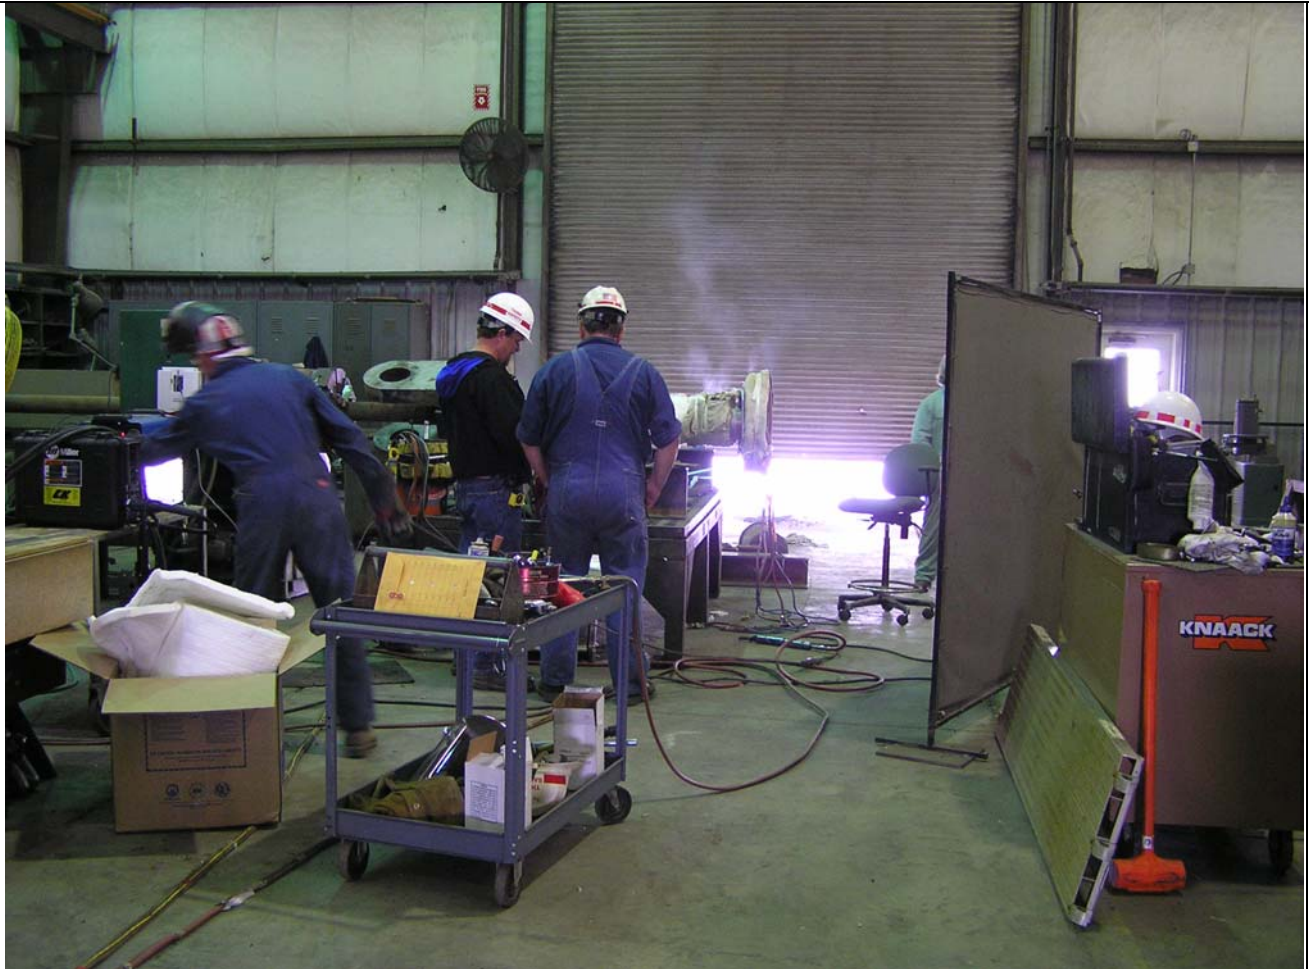
Combined Team begins welding on the strut arms
6 April 2005
Corps of Engineers' Metal Shop
